FLIGHT EXPERIENCE WITH TWO HIGH-SPEED AIRPLANES

HAVING VIOLENT LATERAL-LONGITUDINAL

COUPLING IN AILERON ROLLS

By NACA High-Speed Flight Station

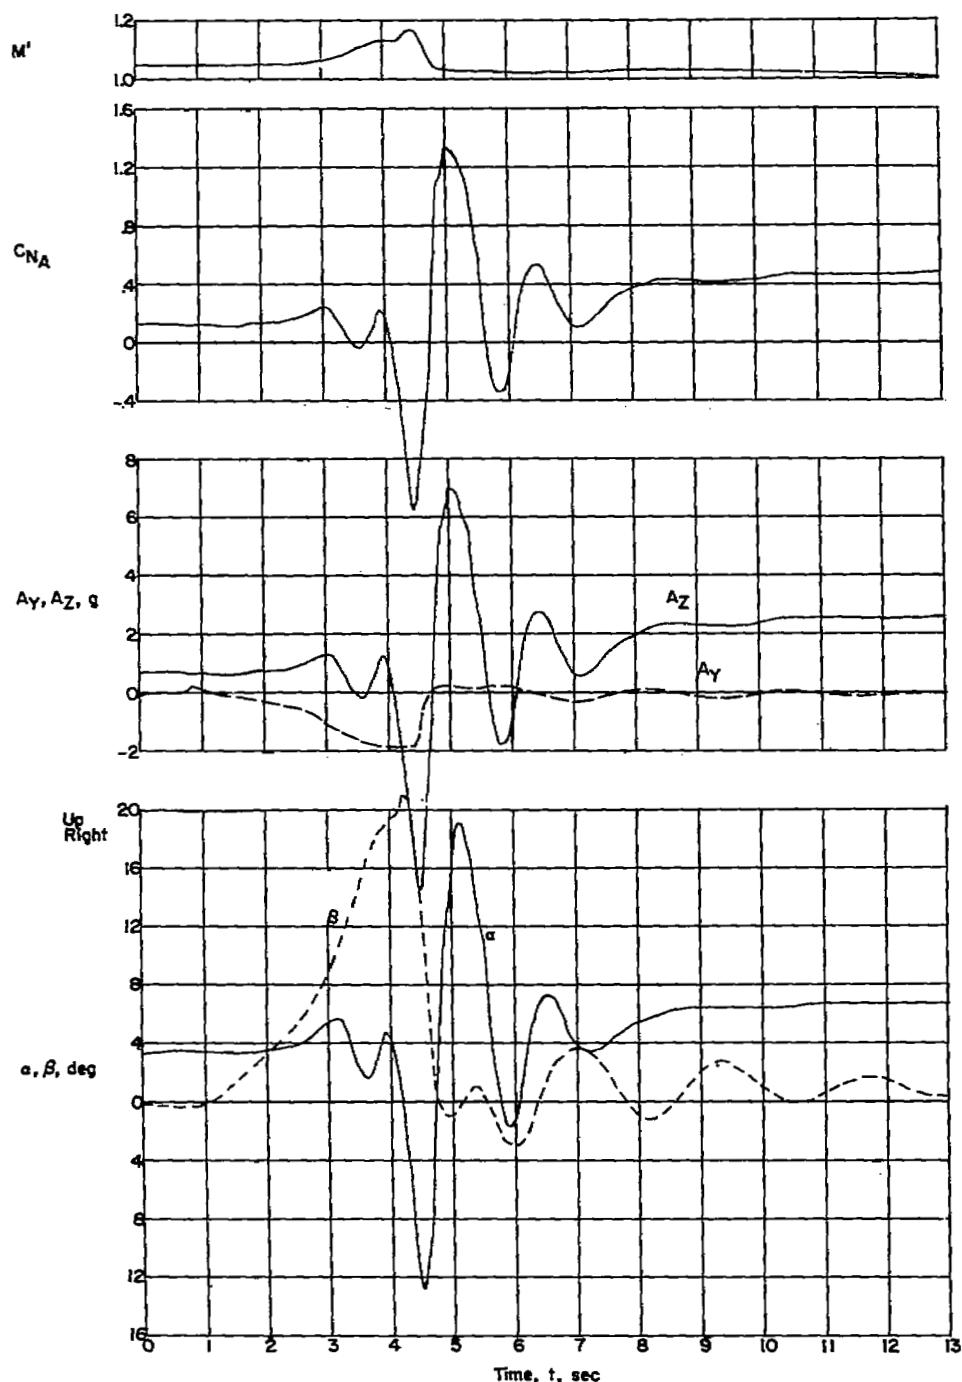
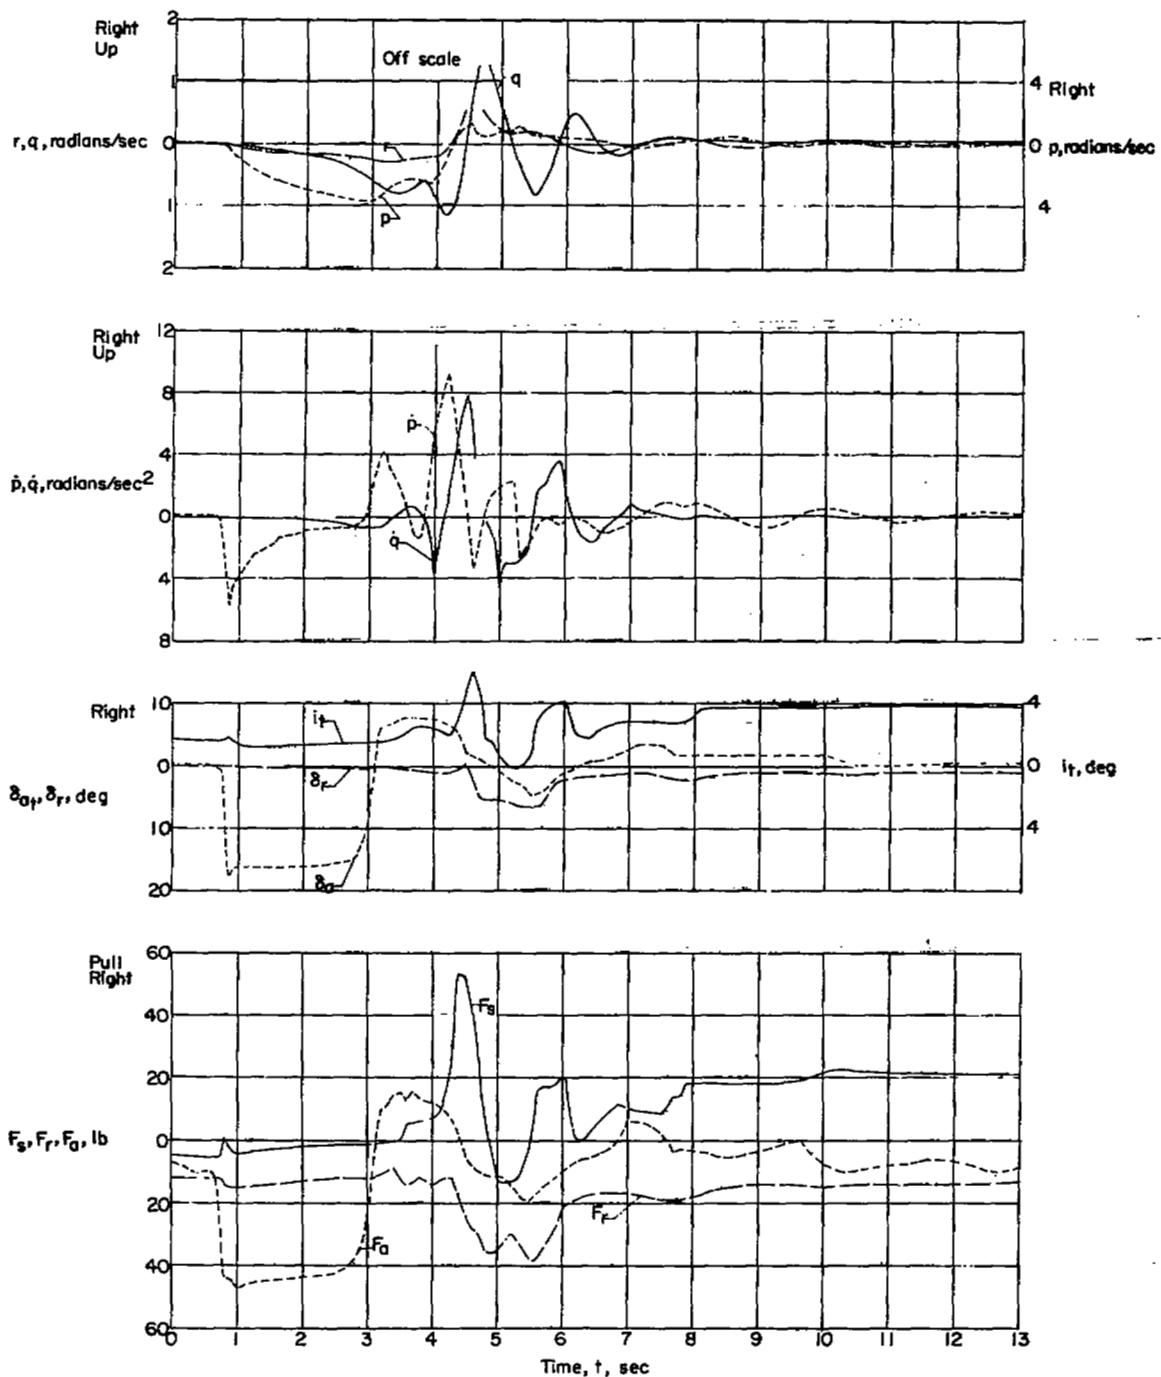
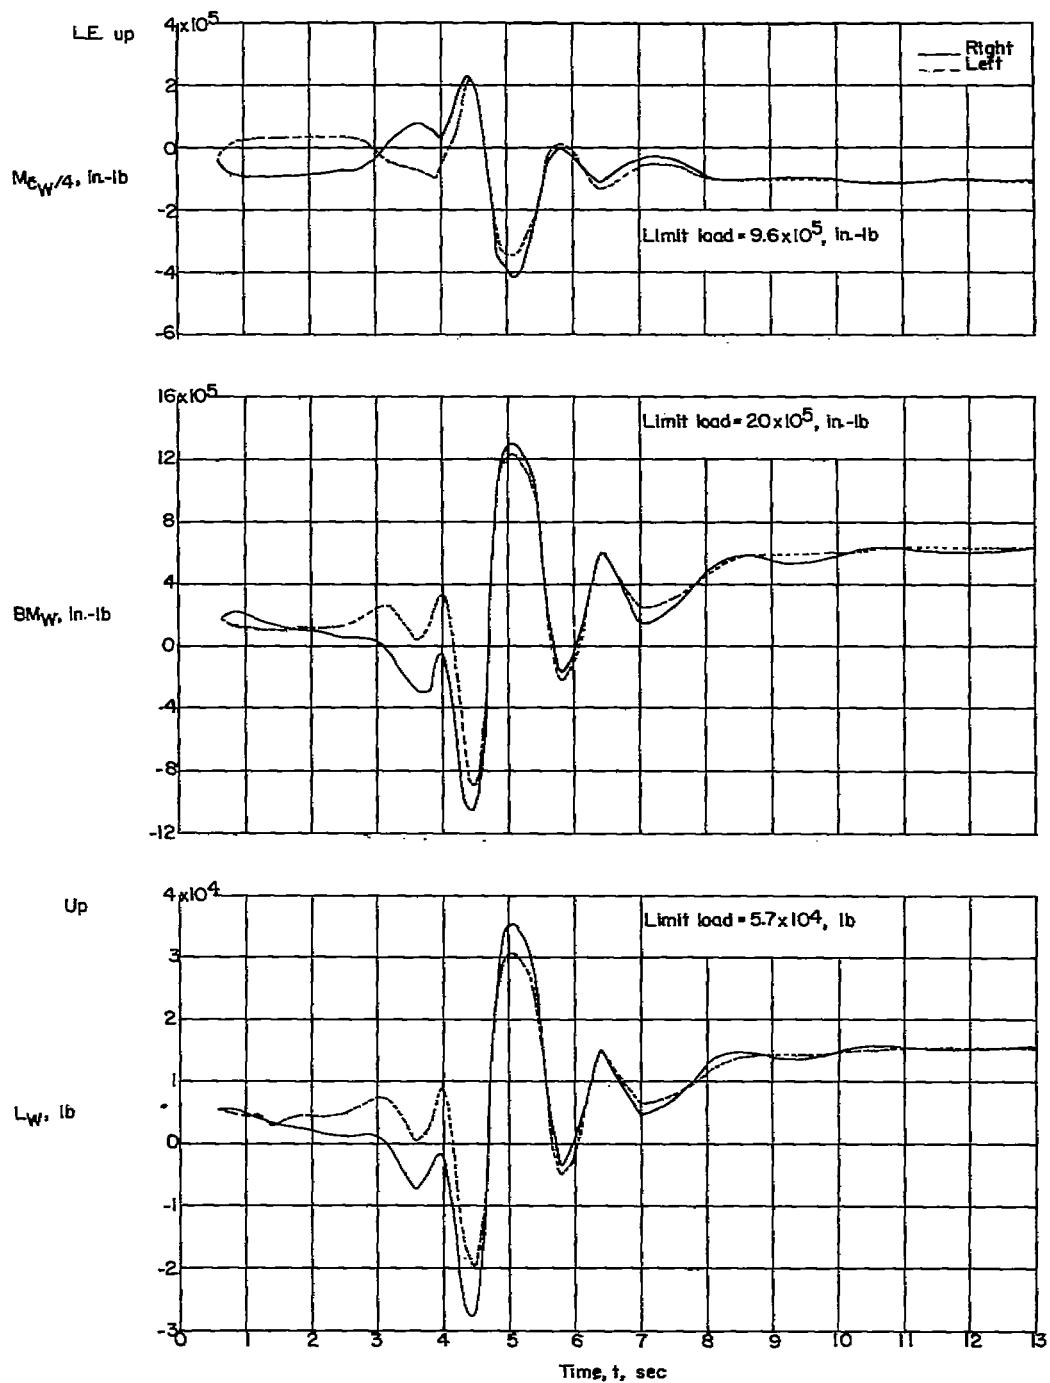
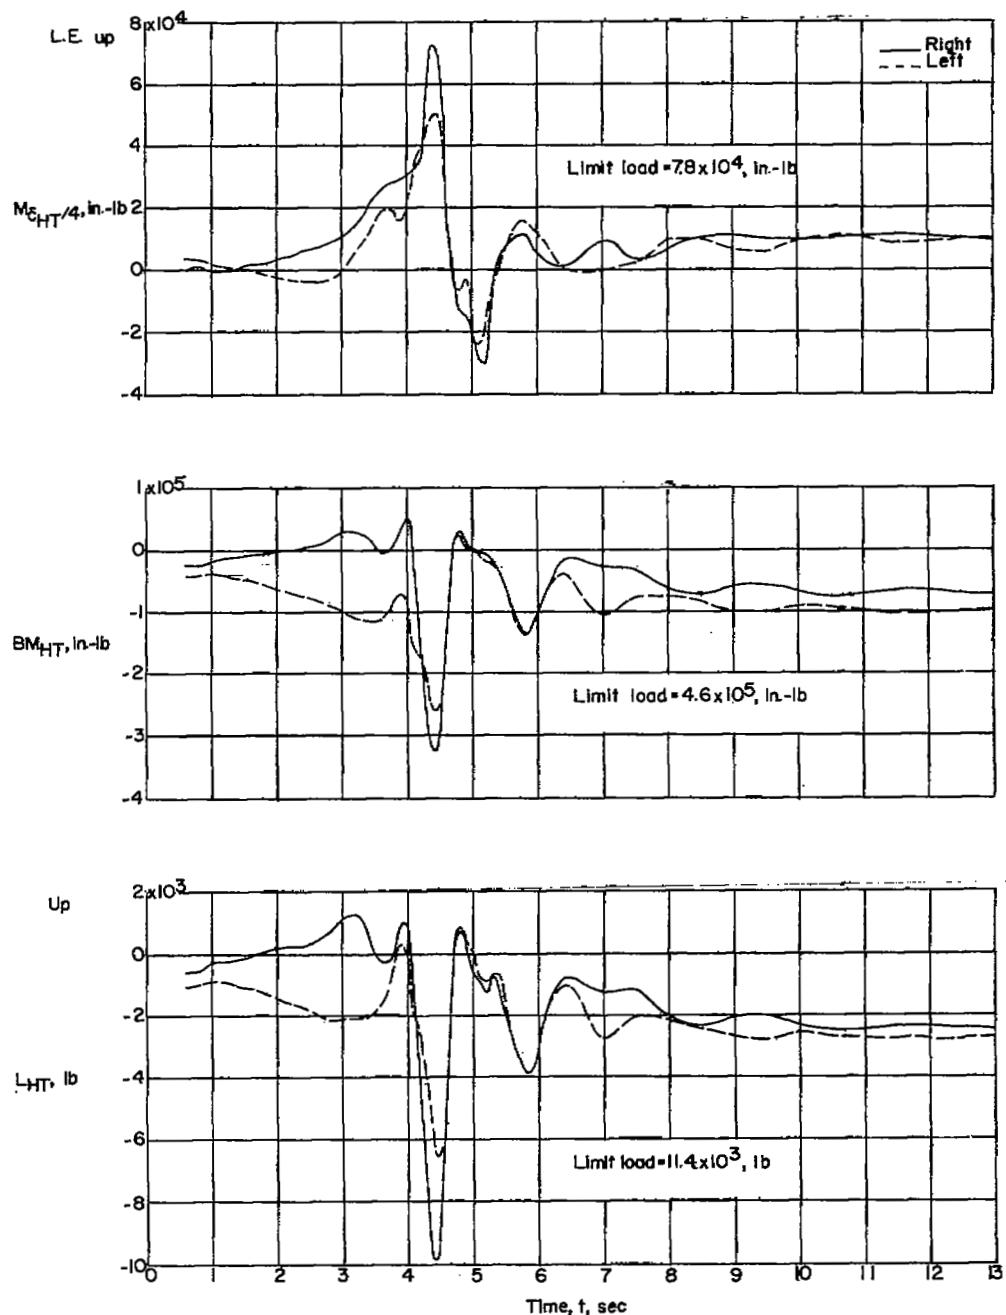
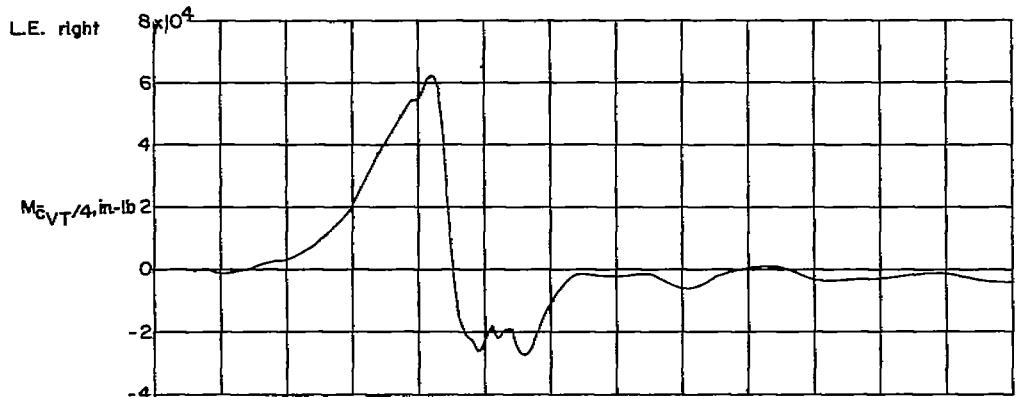
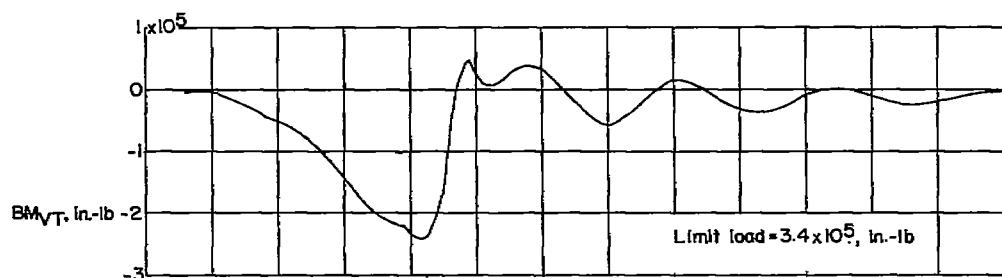
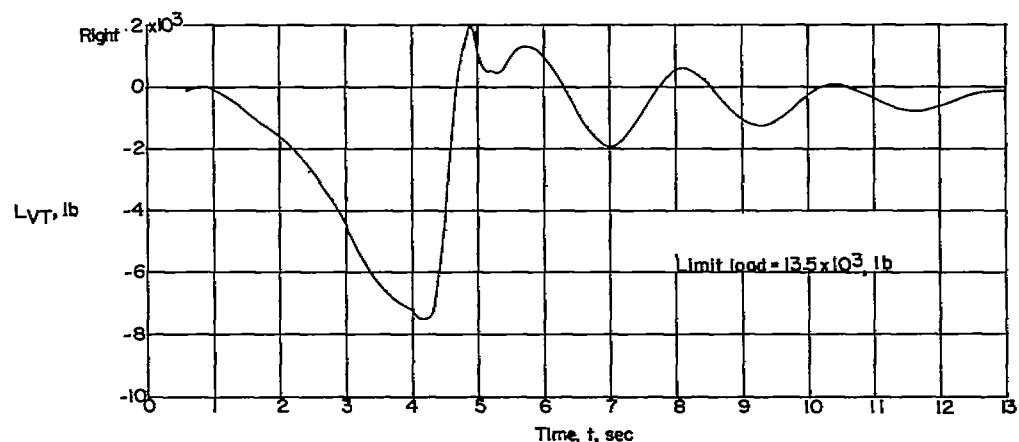
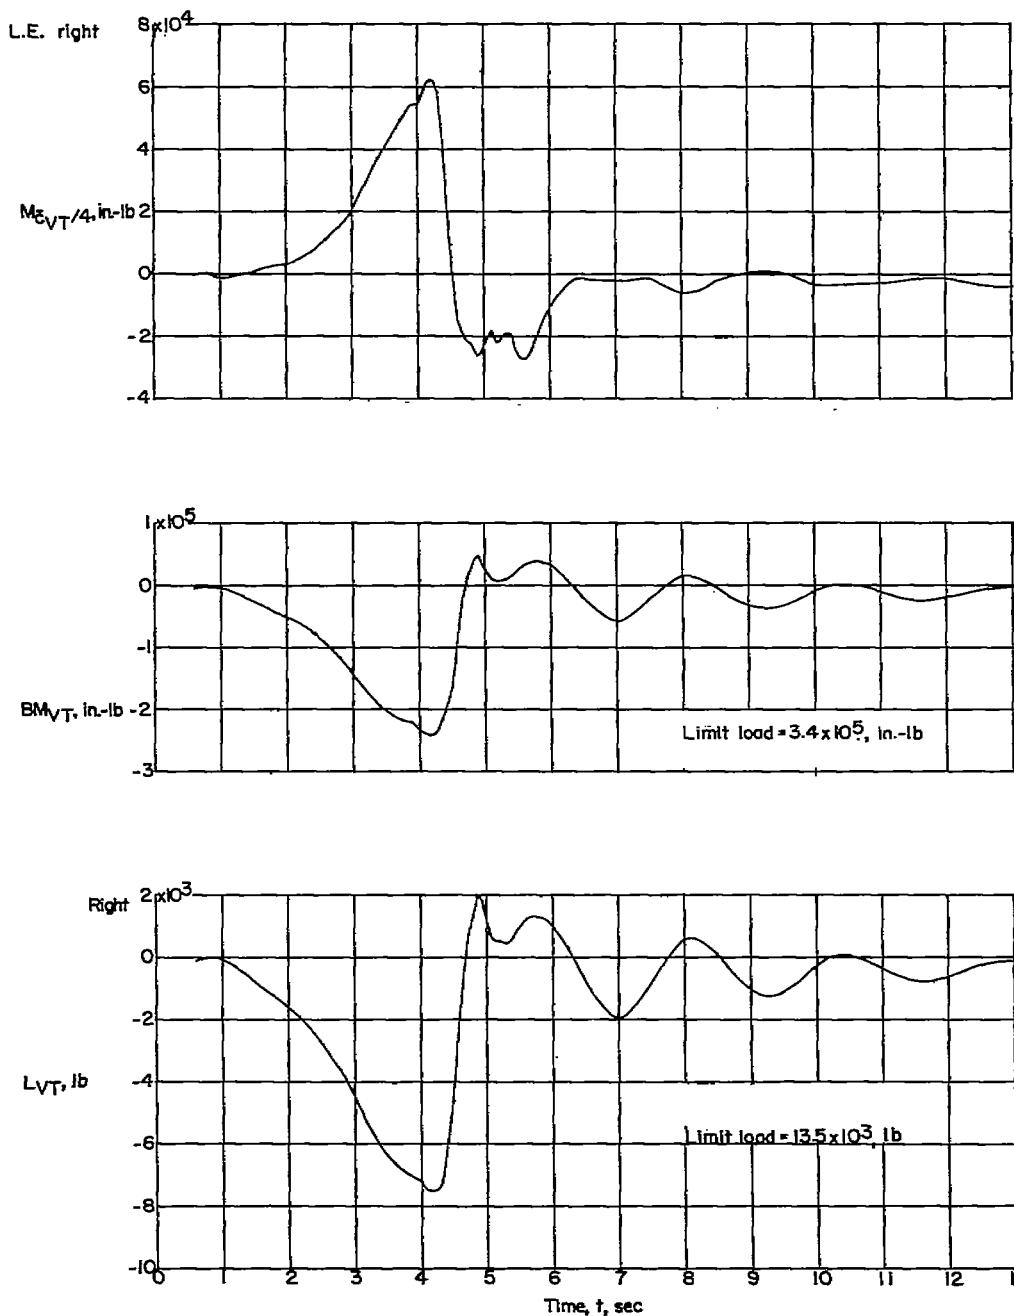
(a) Stability and control plots.

Figure 6.- Time history of quantities measured during an abrupt aileron roll with airplane A at $M = 1.05$. $h_p \approx 30,000$ feet.

(b) Stability and control plots.

(c) Wing structural loads.

(d) Horizontal tail structural loads.

(e) Vertical tail structural loads.

Another left roll time history for airplane A is presented in figure 6 for a Mach number of about 1.05. During this maneuver the favorable sideslip builds up rapidly with roll velocity and peaks at 21° at the time the airplane ceases rolling left. This large sideslip angle results in about 2g transverse acceleration. Near the time at which maximum sideslip occurs ($t \approx 4.0$ sec) a large divergence in pitch develops in the negative direction which attains about -6.7g. The pilot applied control to stop this pitch-down and immediately reduced the control deflection, but was unable to avoid obtaining 7g when the airplane pitched up. Maximum wing loads measured during the maneuver did not approach or exceed the design limit load (fig. 6(c)); however, the fuselage load obtained from airplane weight and acceleration, and horizontal tail loads, and wing load showed maximum values of 63,000 pounds. These maximum values approximated the limit design total load of the fuselage. The measured horizontal tail loads were near limit design load (fig. 6(d)). The maximum measured vertical tail loads reached approximately 50 percent of the limit load (fig. 6(e)) at sideslip angles of 21°. It may be noted that a reduction in vertical tail load with sideslip was experienced at sideslip angles about 8°. In this maneuver, as in figure 5, when the rolling stopped, the airplane motions quickly damped.

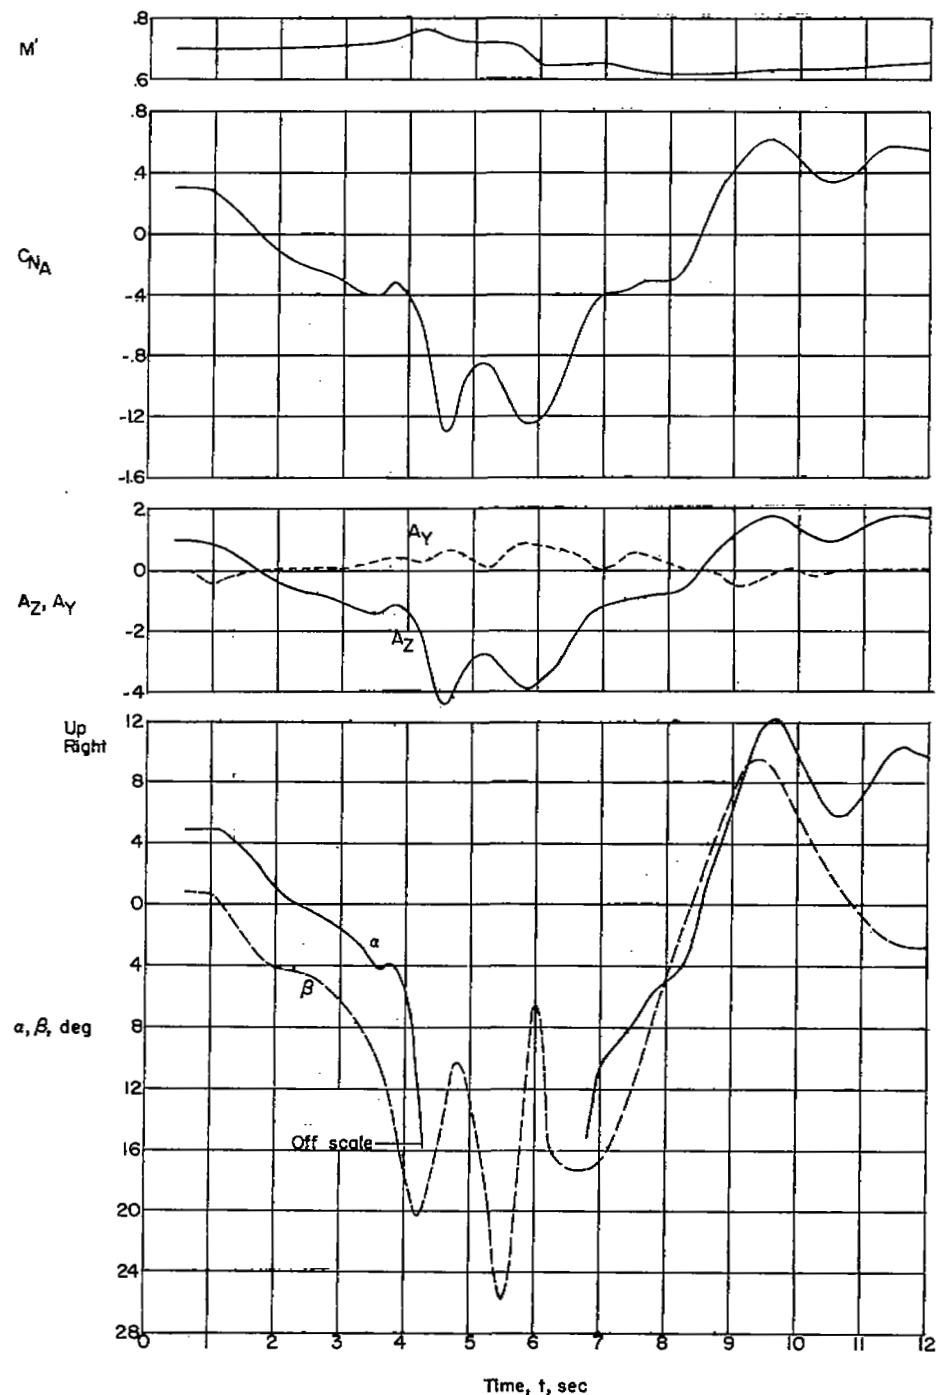
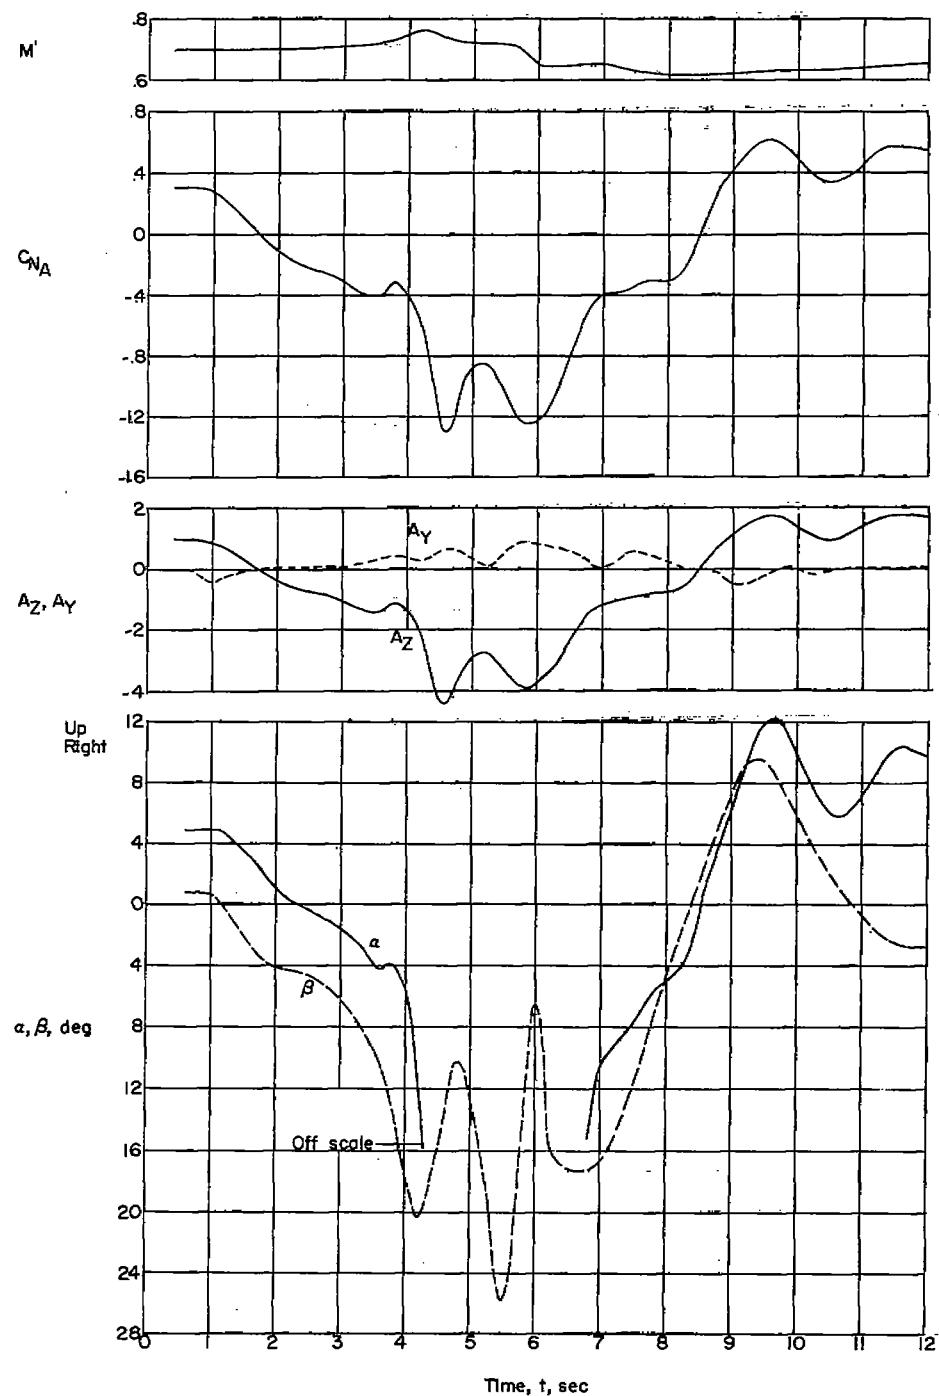
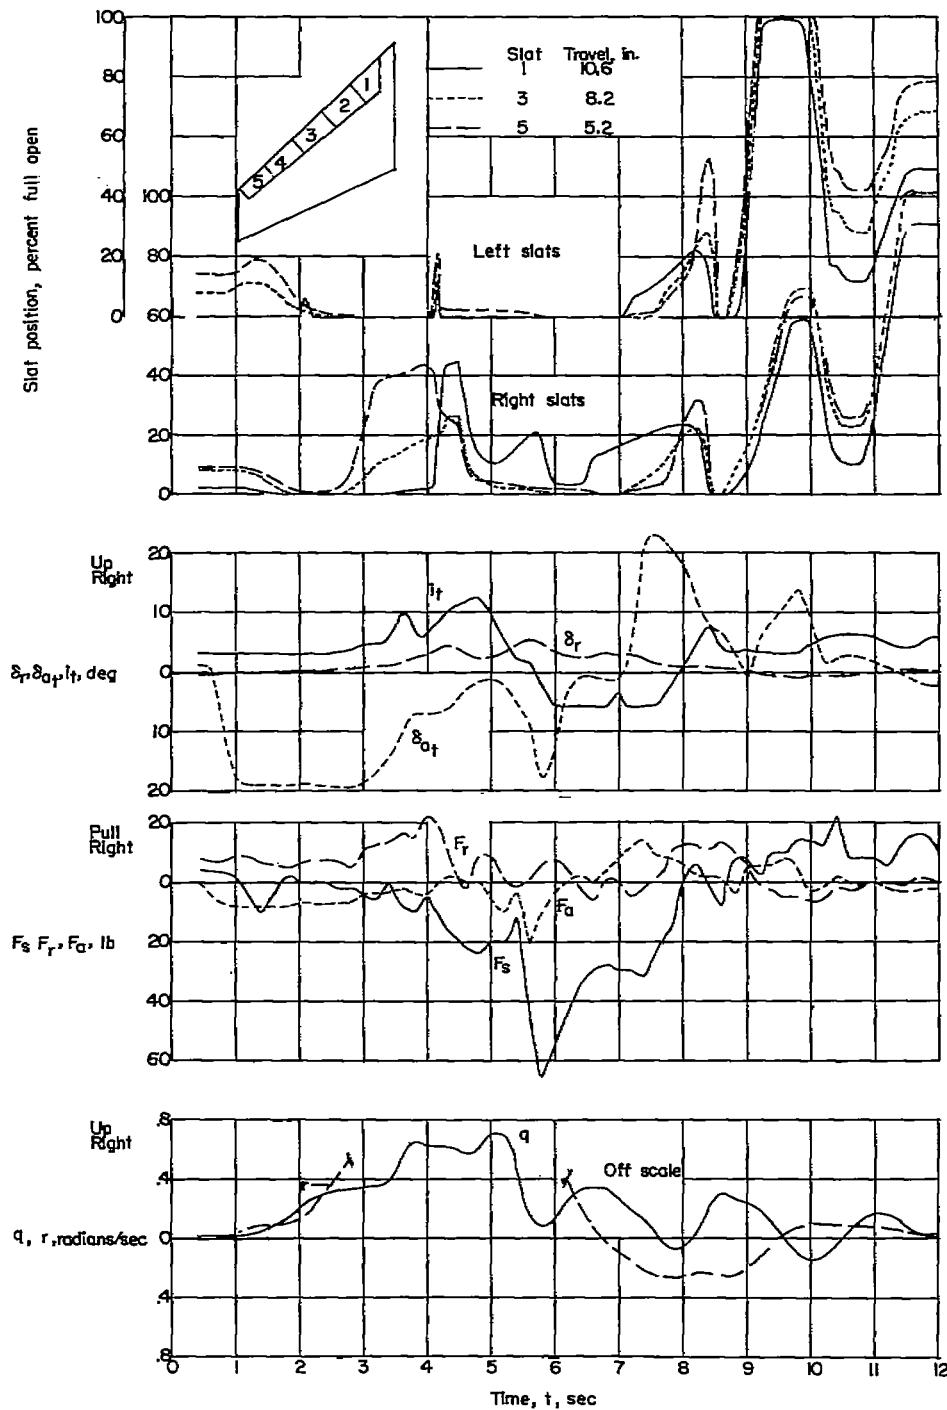
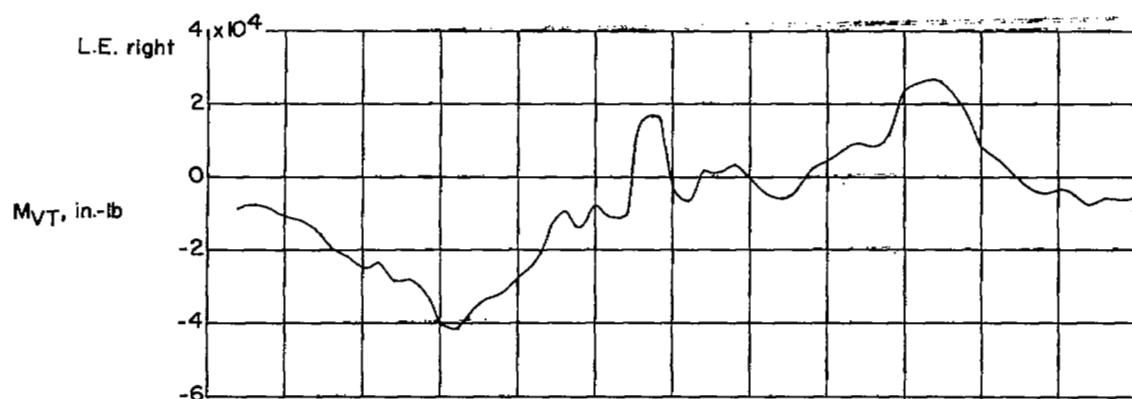
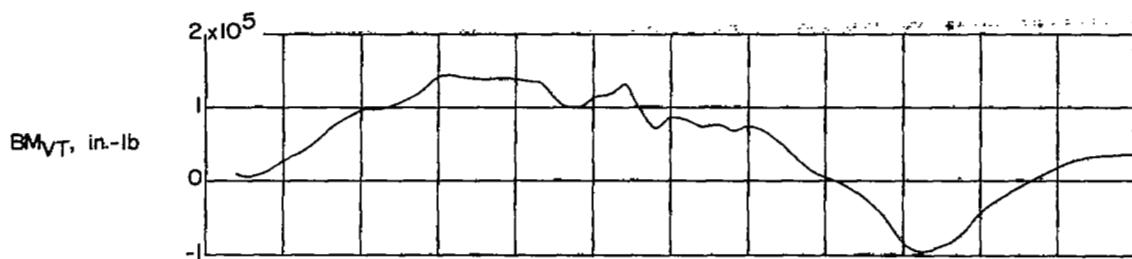
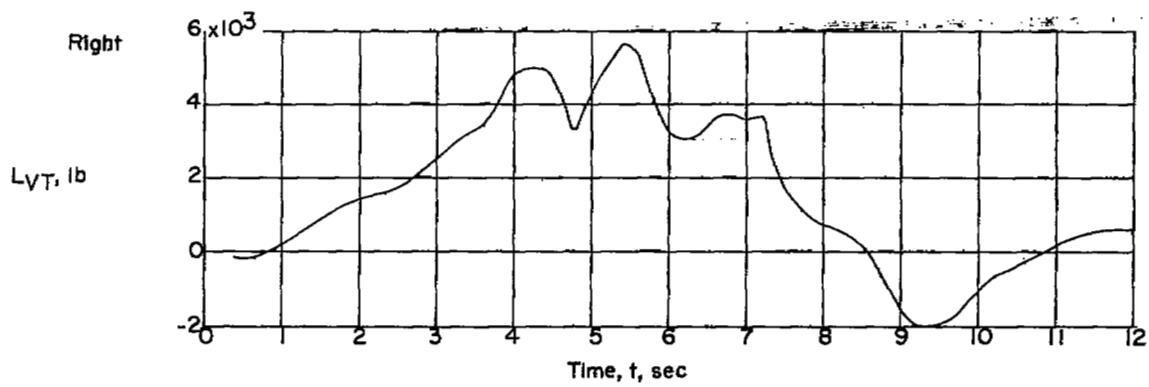
(a) Stability and control plots.

Figure 7.- Time history of quantities measured during abrupt aileron roll with airplane B at $M = 0.70$. $h_p \approx 30,000$ feet.

(b) Stability and control plots.

(c) Vertical tail structural loads.

The measured quantities for an abrupt left aileron roll for airplane B at an altitude of 30,000 feet and a Mach number of 0.70 are shown as

figure 7. Unfortunately, the roll record was lost as a result of instrument malfunctioning. As peak aileron deflection is attained, there is a steady development of left (adverse) sideslip and a progressive decrease in angle of attack. Between $t = 3$ seconds and $t = 4$ seconds, the divergence rates are accelerated considerably and negative angles of attack greater than 16° ($-4.4g$) and left sideslip angles as large as 26° were reached in the more violent stages of this maneuver. Maximum vertical tail loads of 5,500 pounds were measured at a sideslip angle of 26° (fig. 7(c)). It may be noted that appreciable reduction in the rate of increase of vertical tail loads with increase in sideslip angle occurred at a sideslip angle of 7° . It also should be noted that a rather large stabilizer input to oppose the motion and a small rudder input to aggravate the motion were fed in by the pilot. Recovery was affected by bringing the stabilizer and rudder controls close to their initial settings and permitting the airplane to recover. The slat motions shown result from aerodynamic and inertia loads, the slats being free floating but with the segments loosely interconnected.
